SUBJECT: **MBE 4000 Block-to-Cylinder Head Joint Repair Information**

MBE 4000 Cylinder Head to Block Joint Repair Information

Leak Diagnosis, Cylinder Head and Block Repair

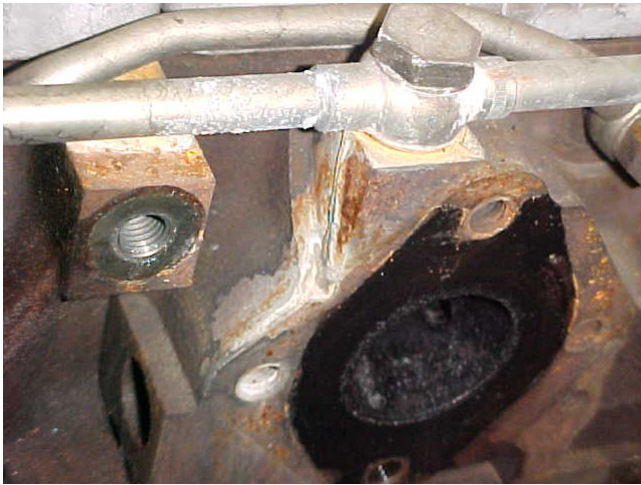
The coolant vent line is often misdiagnosed as a head gasket leak. The coolant vent line is attached to the center top of each cylinder head and is very difficult to see behind the EGR cooler and EGR cooler bracket. However, any leakage from this coolant vent line will show near the head to block joint and down the side of the block. See Figure 1.

Figure 1. Typically any leaks from a properly maintained coolant system will show up as the coolant color or white ash if dry

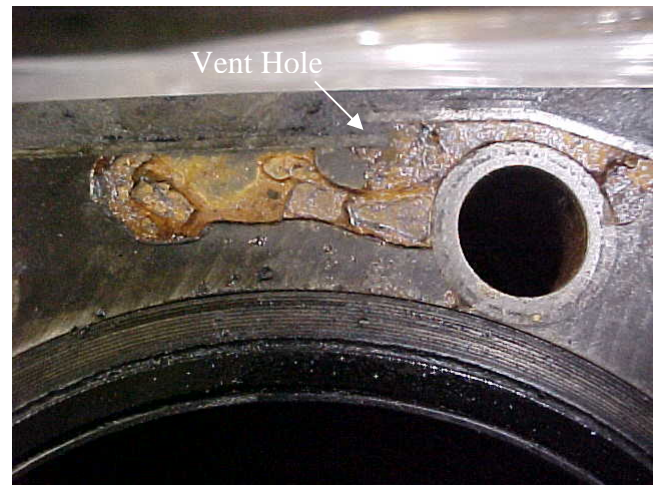
Another area that is misdiagnosed for a leaking head gasket is water (not coolant) seeping from the head gasket vent hole. Any water over the top of the engine drains along the block edge towards the back of the block. As the water passes by the vent hole, a capillary action sucks the water in and drains the water out with the change in engine temperature. This is evident by the rust found near the vent hole side during teardown inspections. See Figure 2.

Figure 2. Head gasket vent hole witness marks

Engines built after Serial Number 0460896913 have head gaskets without a vent hole to address this concern.

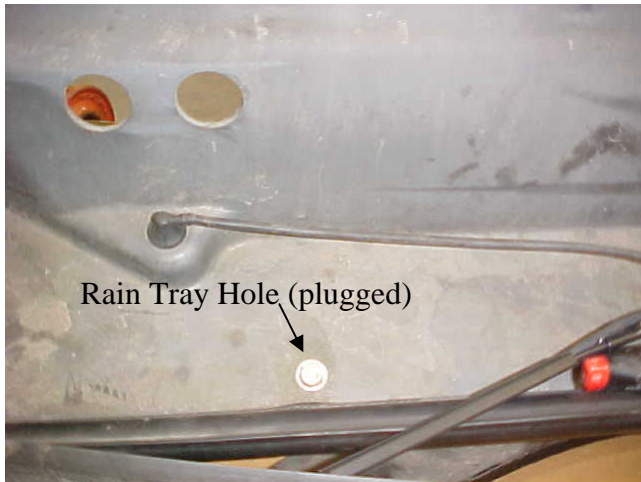
Note: Water draining from the truck's windshield rain tray may also contribute to this situation. Rain tray leaks will generally leave a rusty streak since it is plain water. Head gasket leaks are less rusty in appearance and will generally appear just wet. Rain tray leaks are usually location specific on the engine. Columbia/Century/etc will have rusty streaks between cylinders 5/6 because the rain tray hole is directly above that joint between the cylinders. In Sterling car haulers, the rusty streaks will be up around either cylinders 1/2 or 2/3 because the engine is set farther under the cab in that application. Reference Freightliner bulletin 60-140 and Sterling bulletin 60-21 for more info on plugging the rain tray hole. See Figure 3.

Figure 3. Plugging the rain tray drain hole may reduce water draining on top of engine

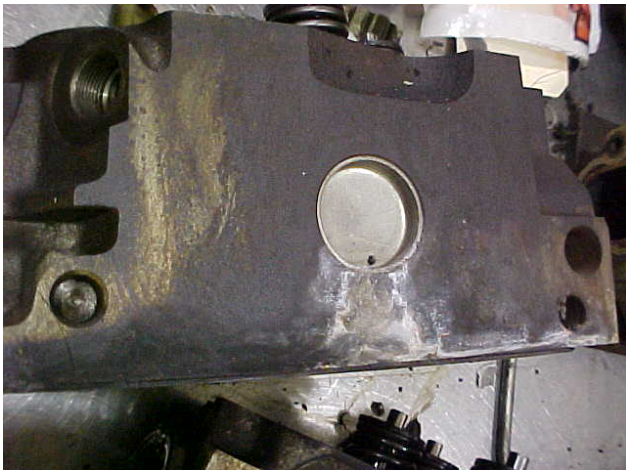
Cylinder head cracks and cup plug leaks will also show up as coolant leak witness marks on the sides of the engine block. Follow the service manual procedure for pressure checking cylinder heads to validate the heads if suspect leaking is found. See Figure 4.

Figure 4. Leaking cylinder head cup plug

Typically the rear of the cylinder head and the rear cup plug have been more prone to cracks and leaks due to being on the exhaust side and exposed to higher temperatures.

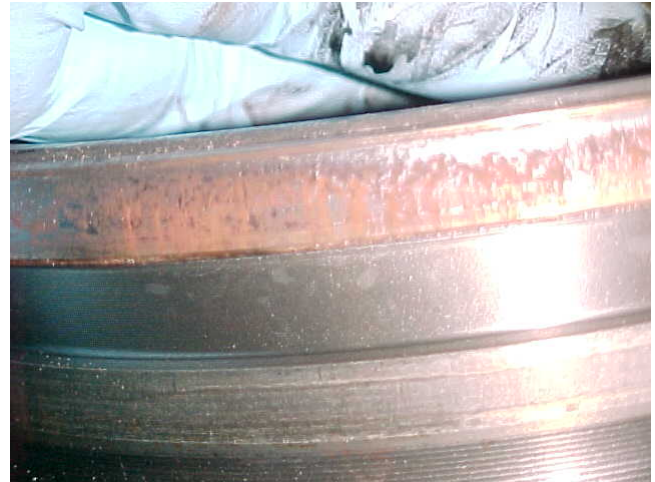
Units with considerable miles or severe duty cycles may have liners that have loosened in the bore. This condition may be evident by erosion and fretting

Figure 5. Fretting around cylinder liner from high mileage

around and under the liner flange. With the release of a new liner, o-ring seal, and counterbore cutting tool, this concern is completely repairable; reference [08 TS-8Rev](#) for complete details on performing this repair. See Figure 5.

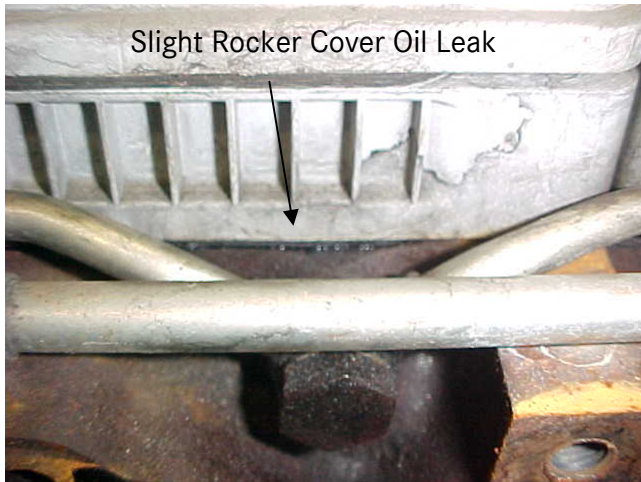
Rocker cover gasket leaks are the predominate source of oil leaks. See Figure 6. This leak will typically be heavy staining of the sides of the block and allow dirt to stick. Normal inspection is made difficult by most of the sealing surfaces being hidden behind other components. Rocker cover gaskets are reusable, therefore tightening of the rocker cover hold down bolts may be the only service required.

Figure 6. Rocker cover oil leak

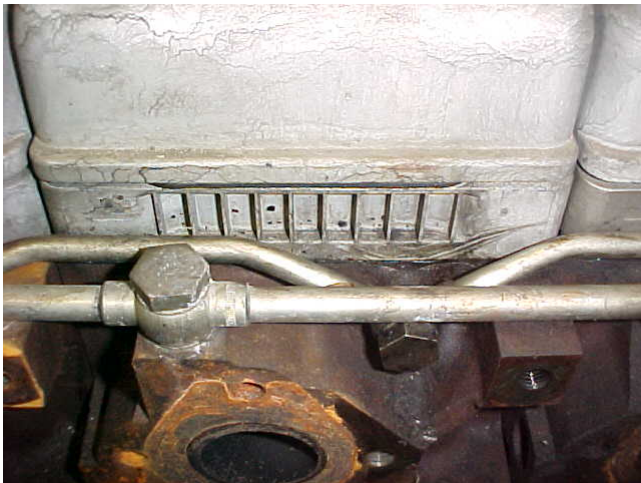
The Constant Throttle Valve line is another possible source of oil leaks to consider. The CTV line is hidden behind the EGR cooler and EGR cooler brackets, there is a connection on the exhaust face of each head and will leave oil traces down the side of the block. See Figure 7.

Figure 7. Oil traces from leaking CTV line

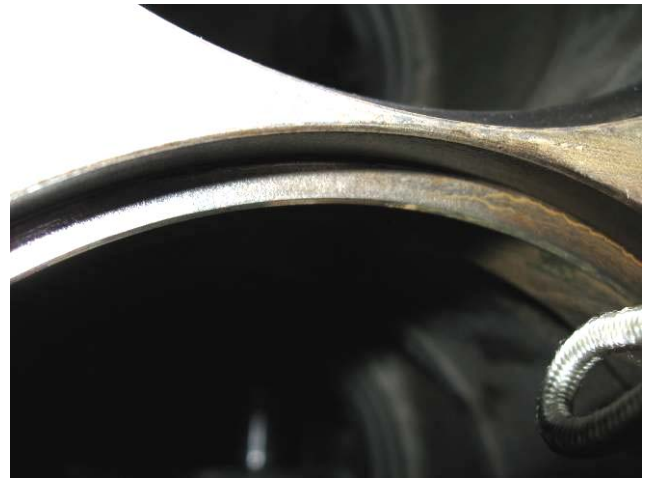
Counterbore cracking is primarily caused from thermal and stress relief of the cylinder block; however, these circumferential cracks have no influence on the sealing area and are acceptable for engine overhaul. See Figure 8. Any erosion of the counterbore can usually be cleaned up with a light cutting. Liner heights are the most important dimension to be maintained for proper sealing. Shim thickness must match the cut depth to ensure the appropriate liner height.

Figure 8. Cracking around counterbore circumference

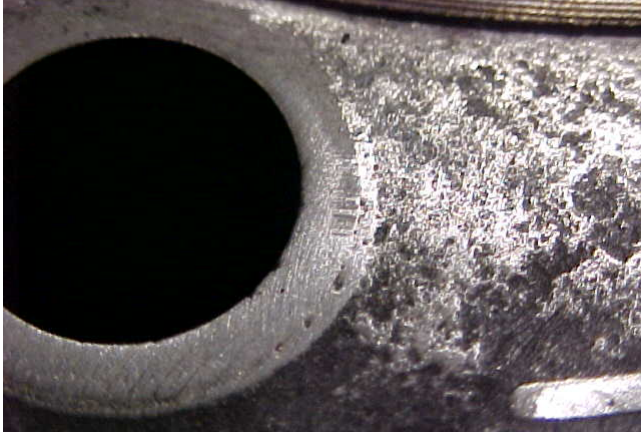
Pitted surfaces that are not in a sealing or grommet area should not be a problem, but they do look bad and if in question or they are in a sealing area there are epoxy products recommended to repair these areas. See Figure 21.

Figure 21. Repairable block surface using Devcon Titanium Putty 10760

Devcon® Titanium Putty 10760 with cleaner is a recommended epoxy for filling in pitting. Also Belzona® 11311 Ceramic R-Metal is considered an industry standard. Follow the manufacturer's instruction when using these products. It is always better to use these products sparingly to minimize the removal of excess material. These epoxies can also be used to fill-in pitting found on the seat of the counterbore. The sides of the counterbore have minimal effect and should not be a concern if pitting is found there. See Figure 22. Contact information for the epoxy can be found at www.devcon.com and www.belzona.com.

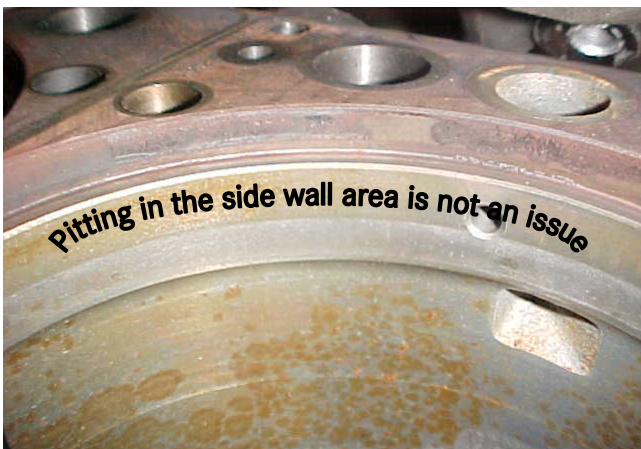
Figure 22. Sidewall pitting is not critical

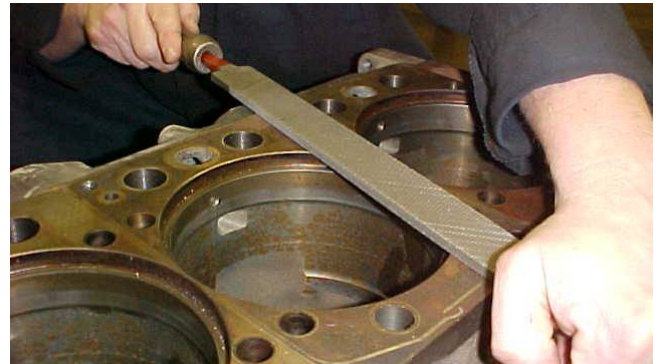
Figure 23. Draw filing the block deck to obtain a perfect sealing surface

After making epoxy repairs to the block surface, lightly finish the top deck by using a stone, a block

and fine emery cloth, or by draw filing. See Figure 23. Minimum to no metal removal is the goal.

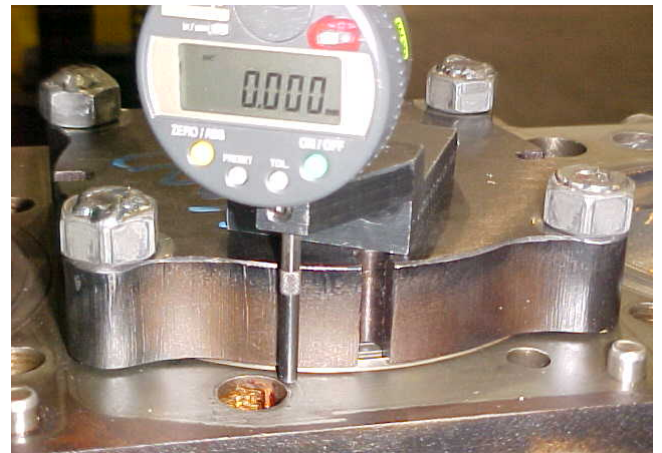
After prepping the block deck and during the liner height measurements, you can use the same tools to qualify the surfaces at the grommet areas. See Figure 24. The areas around the grommets should be within 0.012 mm (0.0005") of the block deck. Appendix B is a Liner Height Data Sheet.

Figure 24. Measuring cylinder liner protrusion

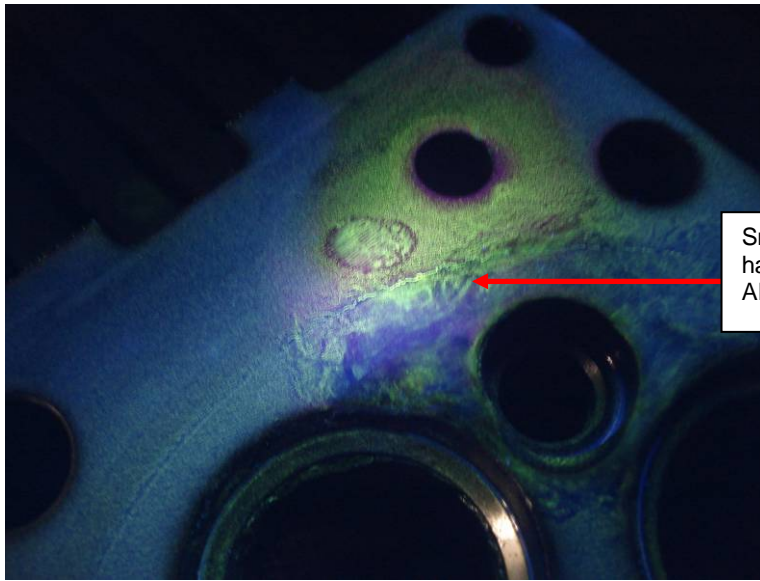
Small indications around the induction hardened areas are normal and ARE ACCEPTABLE.

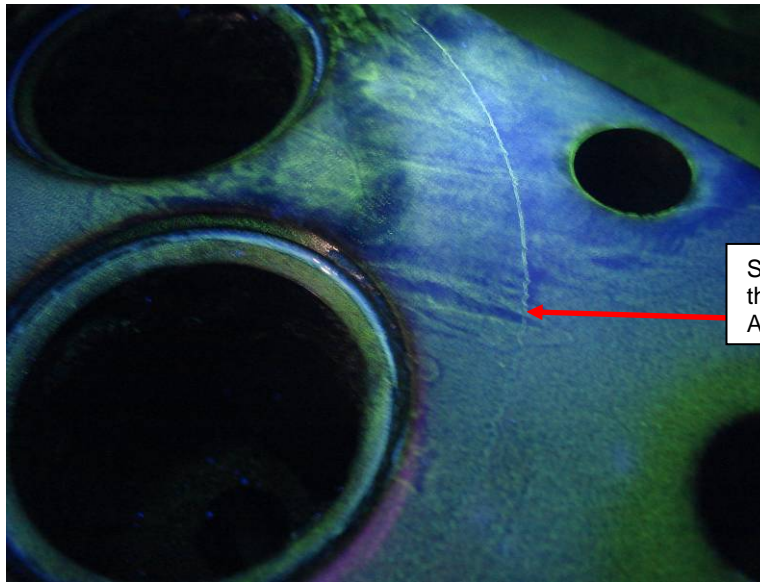
Small indications in a circular pattern around the combustion chamber are normal and ARE ACCEPTABLE.
